APPLICATION CASE HISTORY NO. XXX

Body Maker Cuts Manufacturing Costs, Warranty Service, Improves Product with Loctite® H8000™

Product Line Designed with Adhesive Bonds Instead of Aluminum Weldments Boosts Company's Sales to Ambulance Market

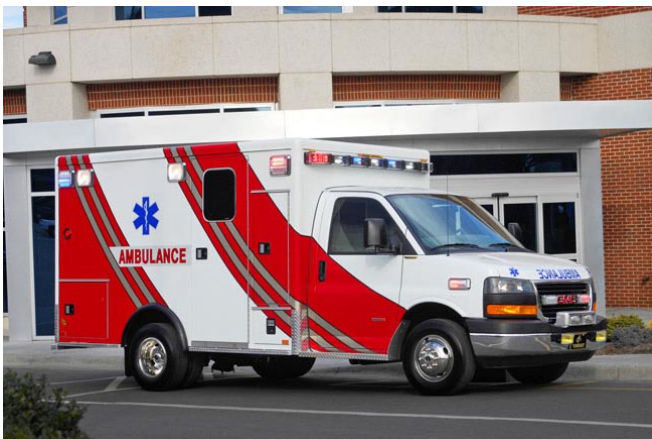
Loctite® H8000™ adhesive is used in the production of ambulance bodies like this Type III model.

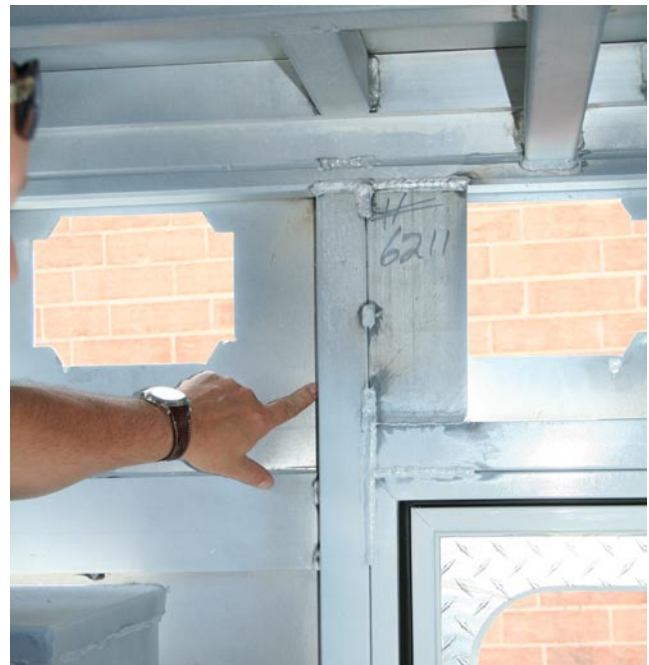
Older body styles used skip-welding to join the aluminum skins and frames. This permitted moisture to penetrate, causing paint and corrosion problems and excessive warranty claims.

In an effort to provide the ambulance manufacturer with better products, the truck body manufacturer took a fresh look at the design of several of its Type I and Type III ambulance body types. One design feature that appeared to leave room for improvement was the joint between the aluminum body panels and the aluminum door framing. Frame members were skip-welded to the outer skin, with a small amount of framing left exposed in the door opening. Over time, part movement would cause paint separation at the joint, allowing moisture to penetrate between the skin and the framework and leading to corrosion.

response. At the same time, the truck body manufacturer had its own reasons for wanting to redesign elements of the ambulance body. Quality specialists had noted that skip-welding resulted in unsightly buckling of the outer skin, and that the spaces between welds represented a second path through which moisture could penetrate the joint. The entire welded-assembly design appeared to be problematic, and it was hoped that these problems could all be eliminated by switching to adhesive assembly. The company contacted its local Henkel representative for consultation.

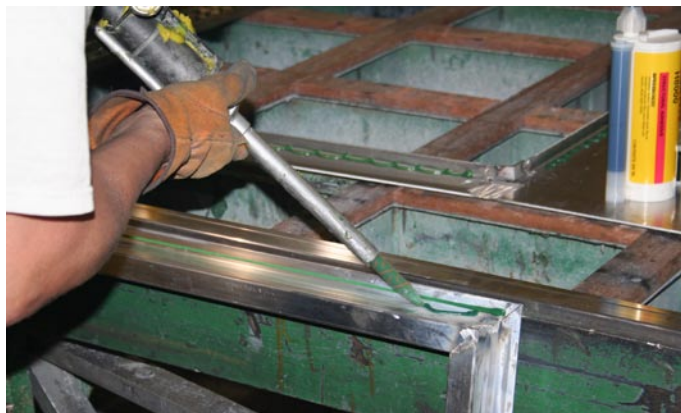
Loctite® H8000™ is used to bond the ambulance bodies' aluminum skin to frame members. The process is quick and economical.

Henkel also provided bulk application equipment and training to assembly personnel. Adhesive is applied over 100% of the length of each skin/frame joint, compared to the roughly 50% bonding achieved previously by skip-welding. In addition, aluminum structural reinforcements are bonded rather than welded to main structural members. Parts are fixtured for about 25 minutes following application.

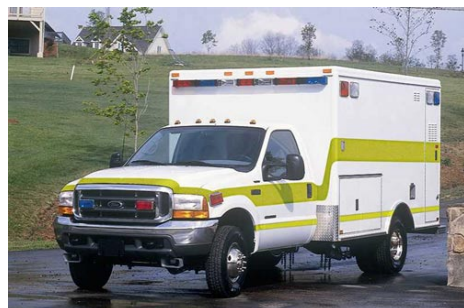
(left) This ambulance looks better on the outside too because of Loctite® H8000™ adhesive

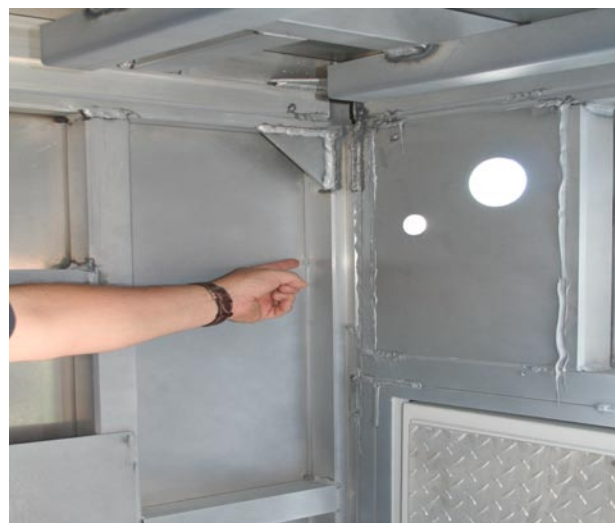
(above) The redesigned full-length adhesive joint is stronger than the earlier skip-welded joint and it excludes moisture, eliminating a source of corrosion.

- The adhesive bond between body panels and door frames is stronger than the welded connection. The redesigned ambulance bodies support 55,000-pound test loads on the roof and sides, exceeding federal standards by more than 200%.
- The full-length bond provides a resilient, water-tight seal against moisture penetration. This eliminated the problems of paint separation and corrosion and drastically reduced the ambulance maker's warranty costs.
- Buckling and dimpling of the skin was eliminated, resulting in improved cosmetic appearance.
- Production time on the door/skin joints was reduced by about 20%.
- Lower-skilled labor can now reliably produce excellent skin/frame joints, reducing labor by \$3 to \$4 per hour compared to the cost of trained welders.
